Watts Branch Watershed Study and Management Plan Final Report

Adopted August 6, 2001
City of Rockville

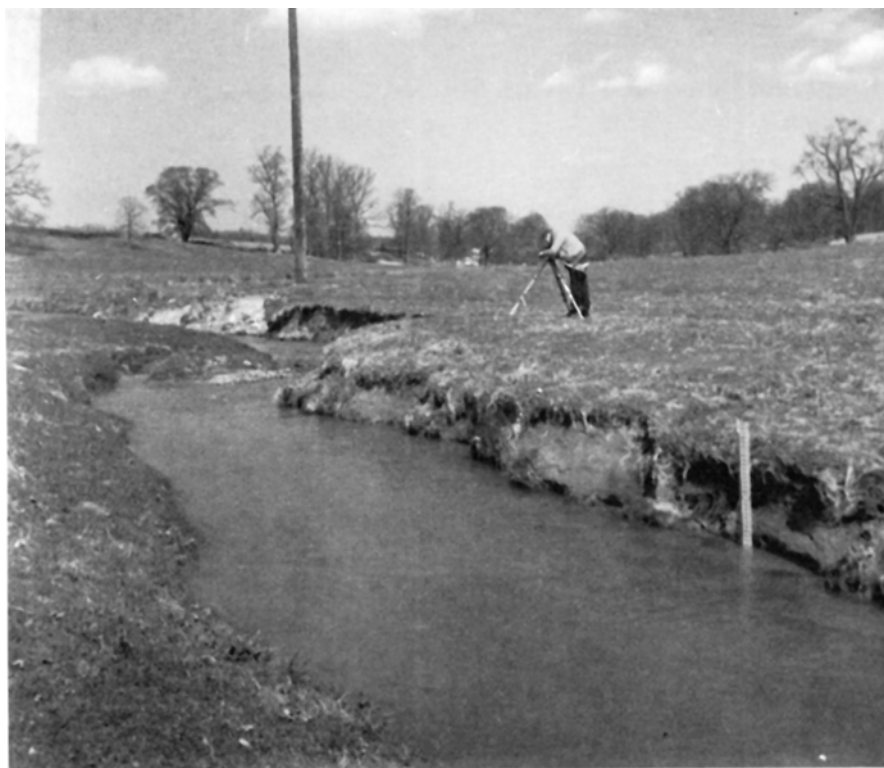
Figure 1.4 Historic photo (circa late 1950s) of Leopold investigation site

Leopold surveyed approximately 14 monumented cross sections along the main stem of Watts Branch in the vicinity of Woottons Mill Park every other year over a 20 year period (1953-1972). Figure 1.4 is a photograph of the area studied in the late 1950s. As can be seen, this reach of Watts Branch was largely in an agricultural setting.

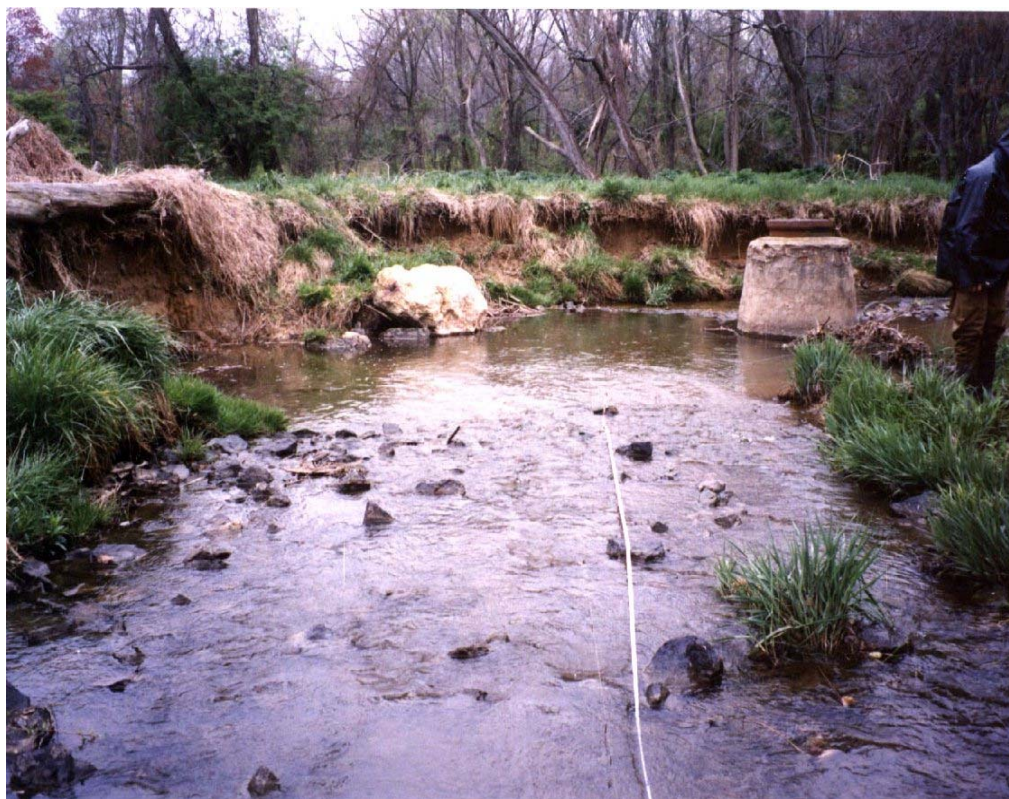
Channel enlargement is also quite apparent in the field (Figure 2.3; same cross-section as shown in Figure 2.2). The exposed sanitary sewer manhole in the channel is due to a combination of plan form (i.e., lateral) adjustment of the channel as well as enlargement.

Figure 2.3 Photo looking downstream showing exposed manhole and enlarged channel
